UM-3727-98
1998 Ford Escort

In-depth Vehicle Occupant Report

The University
of Michigan
Transportation
Research Institute

UM-3727-98

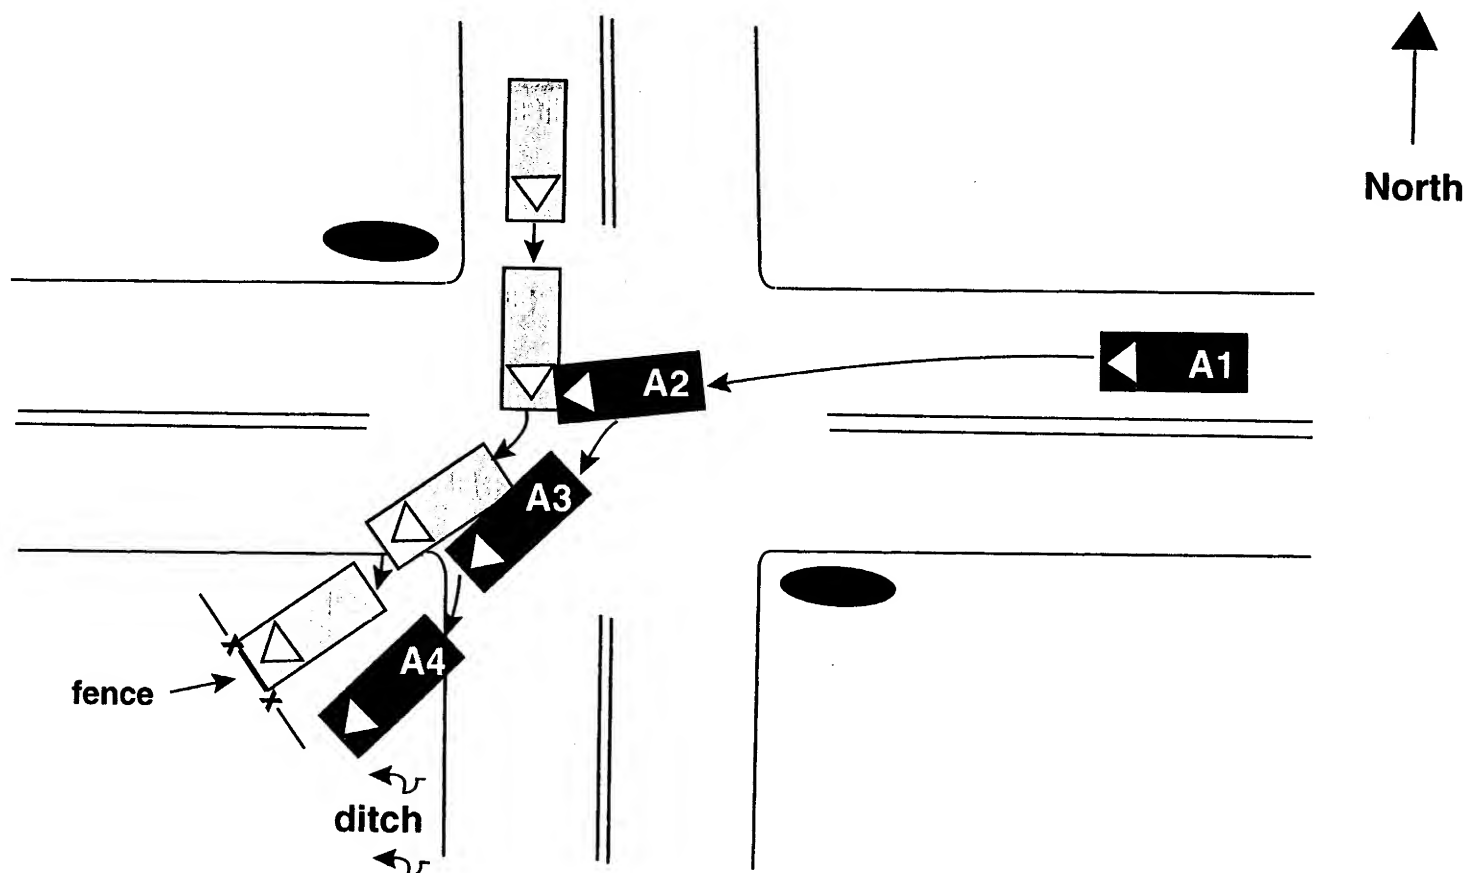
ACCIDENT SCHEMATIC

ACCIDENT DESCRIPTION: CASE VEHICLE (A) WAS TRAVELING
WEST AT A DRIVER-ESTIMATED SPEED OF 89 KPH
(55MPH) IN THE WESTBOUND LANE. VEHICLE (B) WAS

STOPPED AT THE STOP SIGN FACING SOUTH. AS CASE VEHICLE (A) APPROACHED THE
4-LEG INTERSECTION, THE DRIVER OF VEHICLE (B) BEGAN CROSSING THE WESTBOUND
LANE, SO AS TO TRAVEL SOUTH. THE DRIVER OF CASE VEHICLE (A) BRAKED AND STEERED
TO THE LEFT, BUT WAS UNABLE TO AVOID STRIKING THE LEFT SIDE OF (B). AFTER THE
IMPACT, BOTH VEHICLES ROTATED AND STRUCK AGAIN.

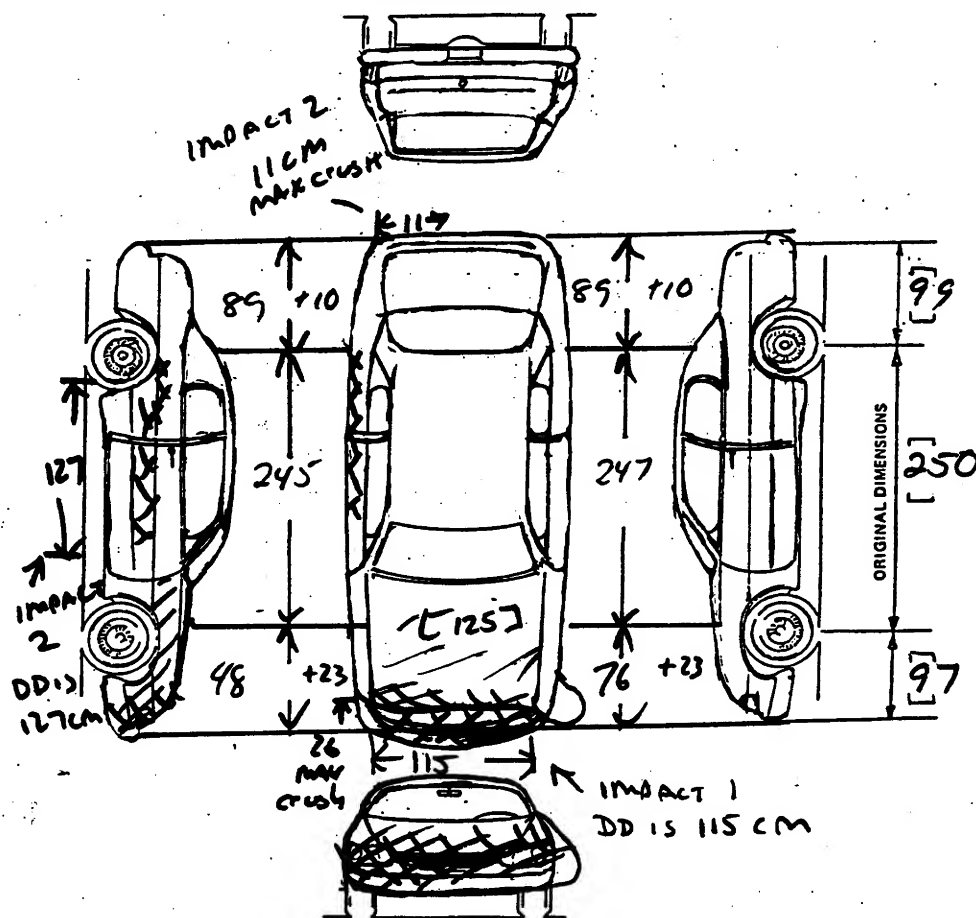
VEHICLE DAMAGE

Direct Damage Length (DDL) 115 cmFront-End Overlap (Percent) = $\frac{DDL}{UEW}$ 115 134 86 %Vehicle Overlap (Percent) = $\frac{DDL + 1/2 (OAW - UEW)}{OAW}$ 115 + 1/2 (171 - 134) 171 78 %
